Maryland Inventory of Historic Properties number: BA-2788

Name: MD 146 over Little Impoundment Falls

MARYLAND INVENTORY OF HISTORIC BRIDGES
HISTORIC BRIDGE INVENTORY
MARYLAND STATE HIGHWAY ADMINISTRATION/
MARYLAND HISTORICAL TRUST

SHA Bridge No. 3089 Bridge name MD 146 over Little Gunpowder Falls

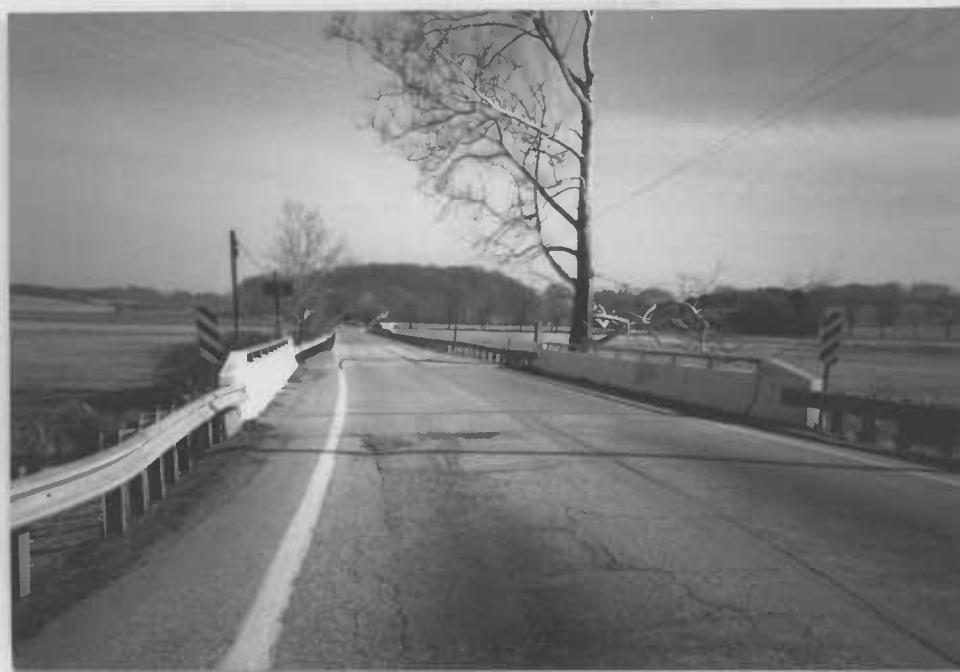
1. BA-2788
2. MD 146 over Little Gunpowder Falls
3. Ba Ho Co. MD
4. Eric Greffitts
5. 3/97
6. MD SHPO
7. W elevation of bridge
8. 1 of 5

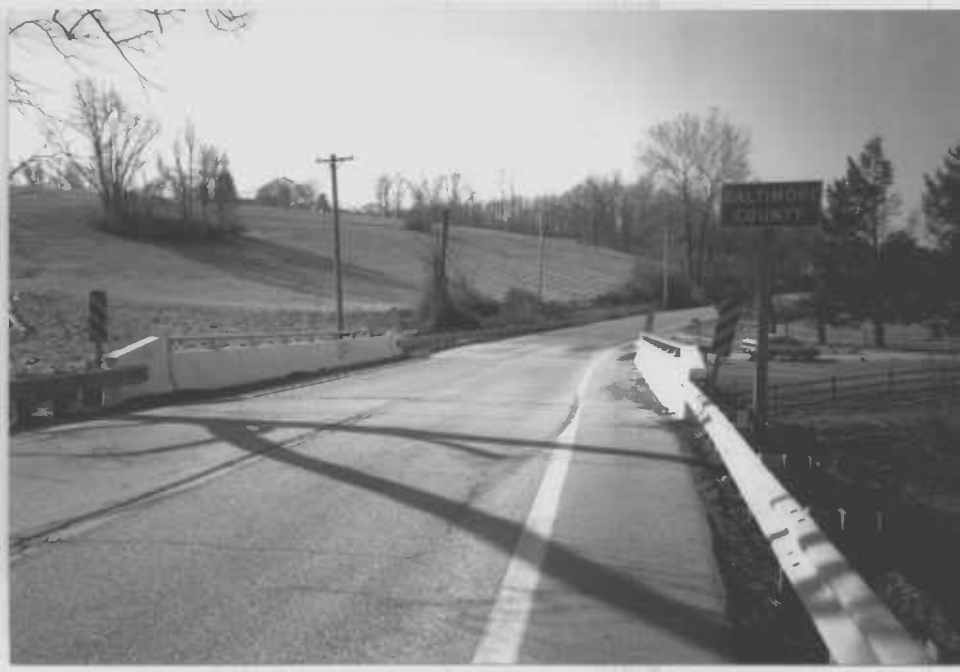
1. Br 2788
2. MD 146 over Little Gunpowder Falls
3. Belto. Co MD
4. Eric Griffiths
5. 3/97
6. MDSHPD
7. detail of girders + S abutment
8. 2 of 5

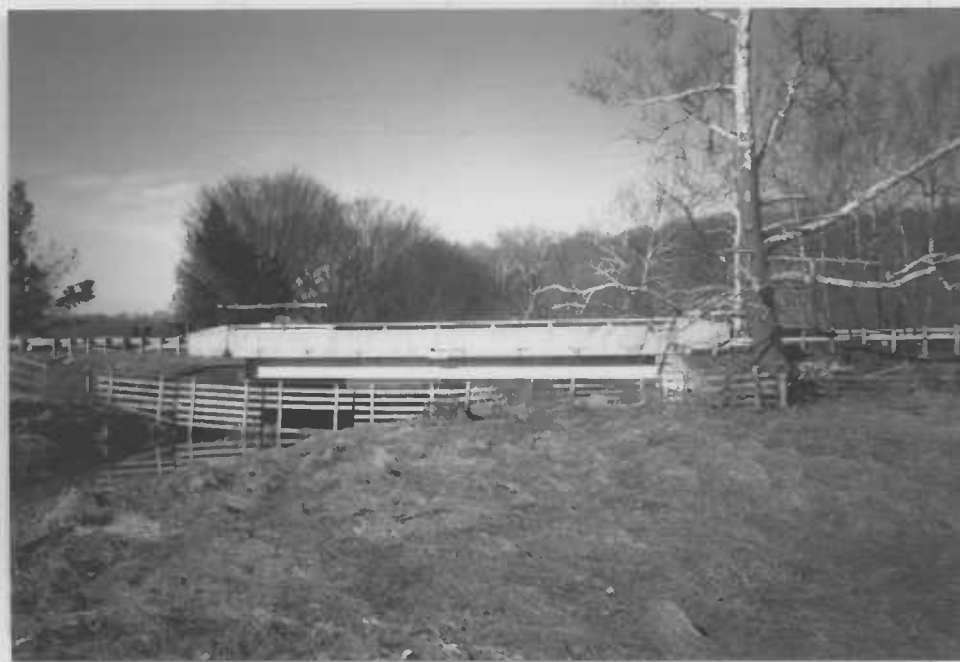
1. BA 2788
2. MD 146 over Little Gunpowder Falls
3. Balt. Co. MD
4. Eric Gruffitts
5. 3/97
6. MD SHPO
7. S approach
8. 3 of 5

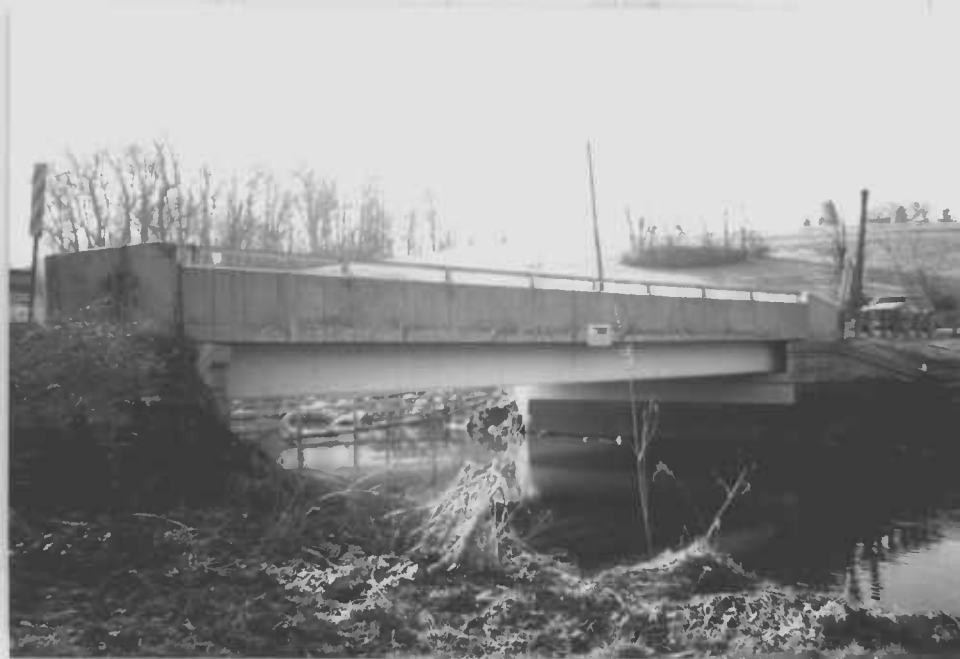
1. BA-2788
2. MD 146 over Little Gunpowder Falls
3. Balto Co MD
4. Eric Druffitts
5. 3/97
6. MD SHPO
7. E elevation
8. 5065
